# TSS-1R Mission Failure Investigation Board

## Final Report

National Aeronautics and Space Administration

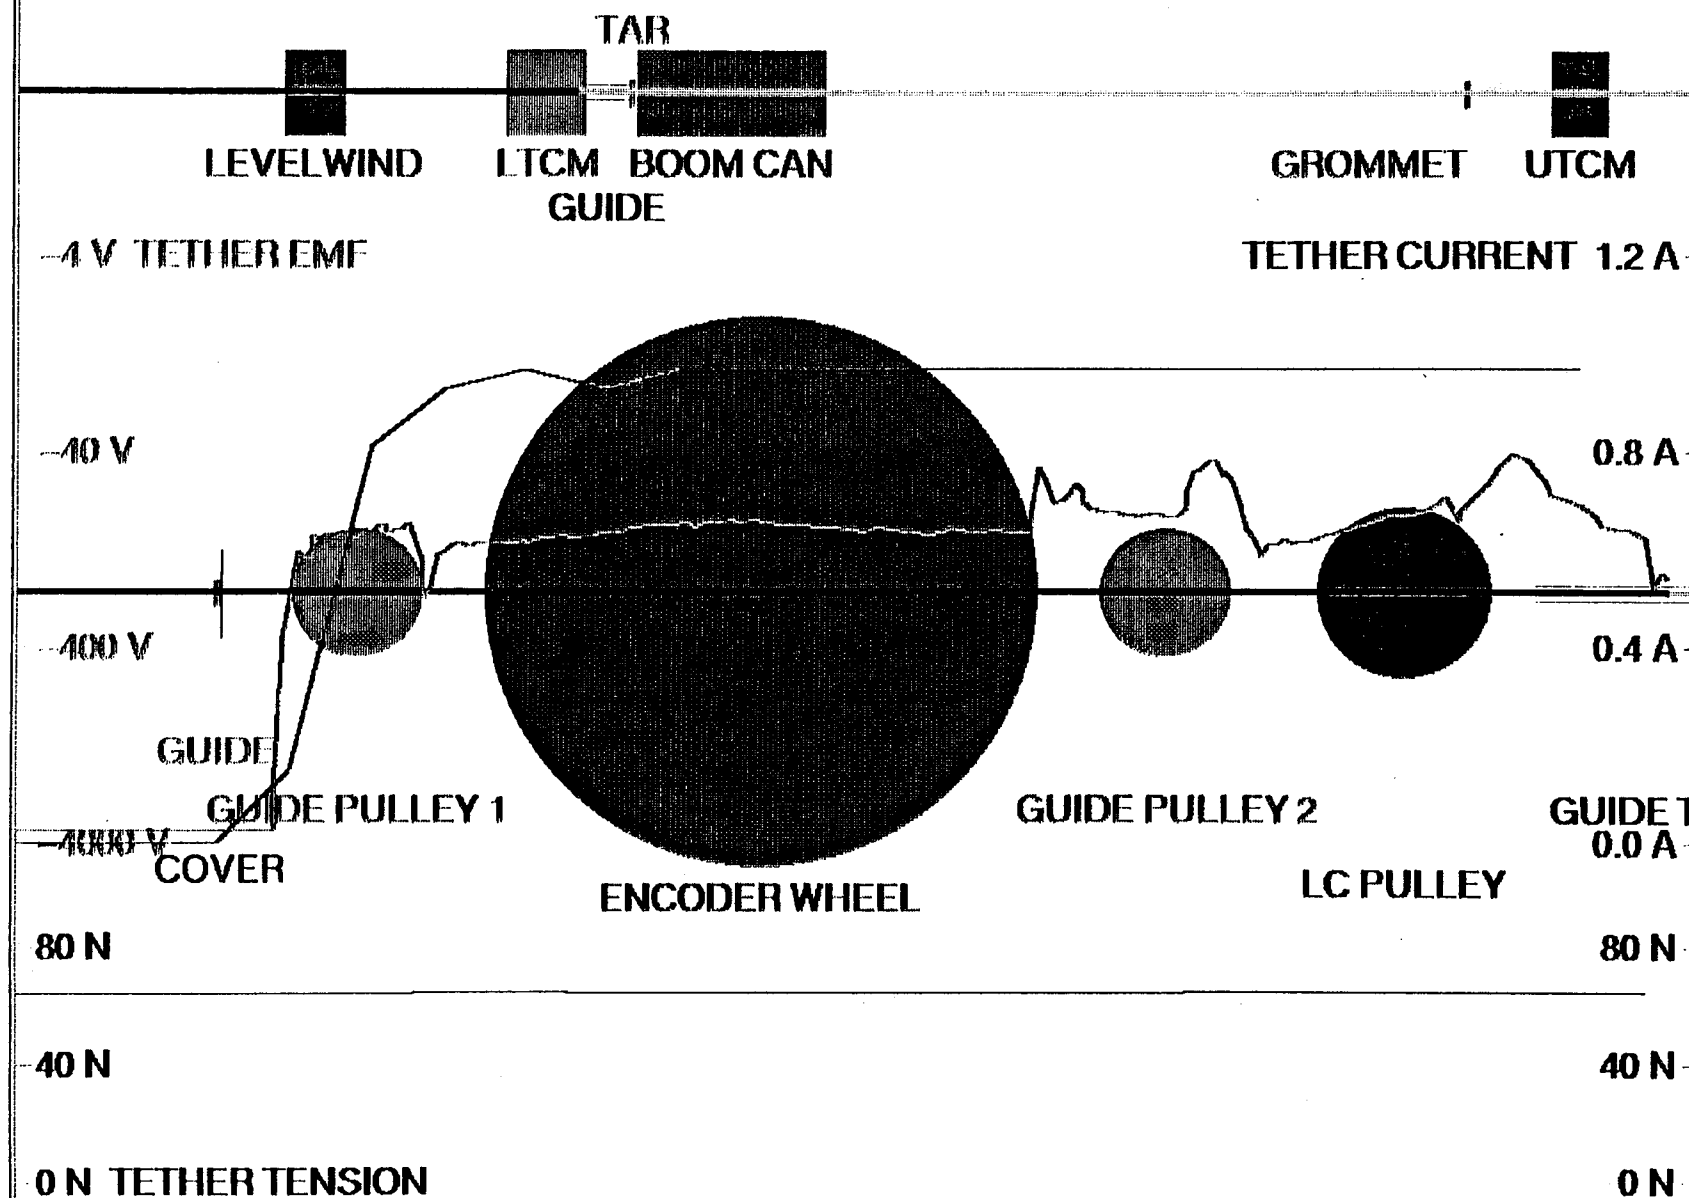
Figure 3.6-1

Figure 3.6-1: As the damaged point of the tether entered the LTCM and contacted the first pulley, at 57/01:29:16.9, the tether voltage decreased in magnitude from -3500 VDC to approximately -200 VDC and the current increased from 0.0 A to approximately 0.8 A as the initial arc began.

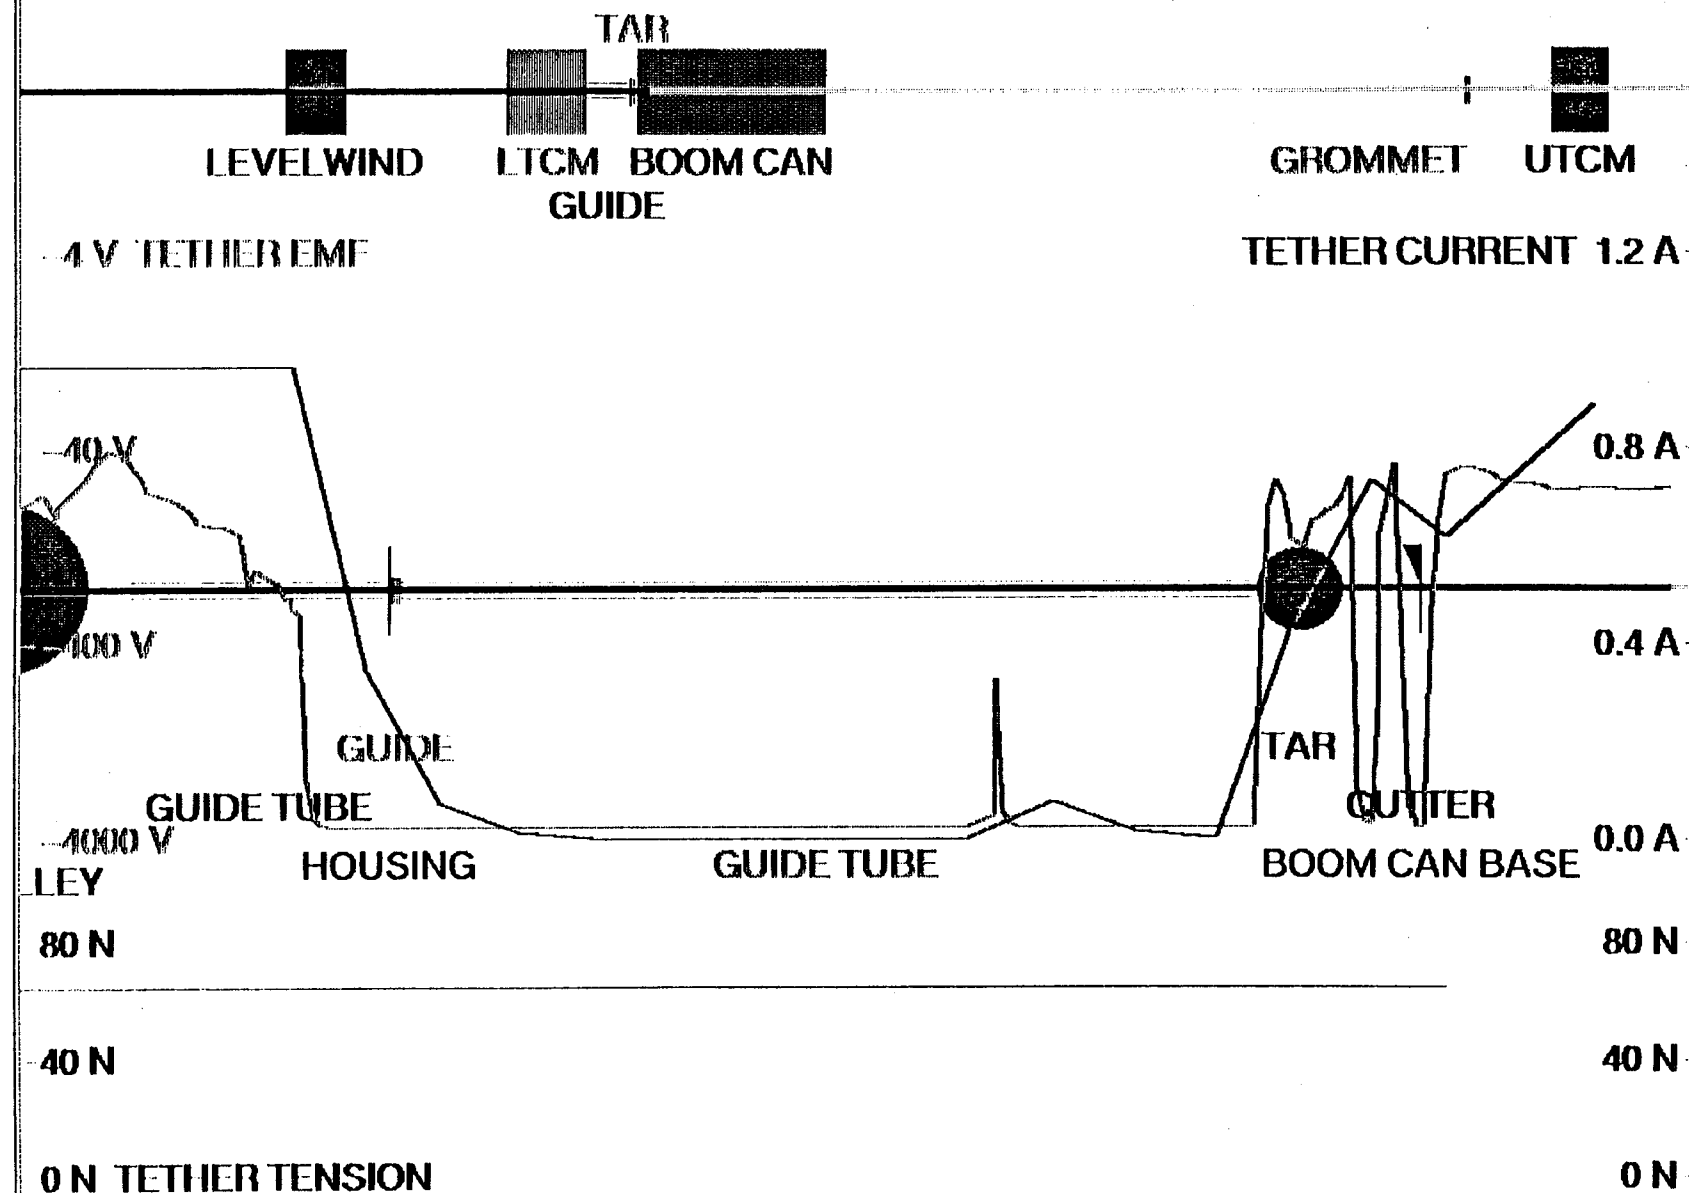
Figure 3.6-2

Figure 3.6-2: At 57/01:29:17.9, the damaged tether point leaves the LTCM exit guide tube. The current remains steady at 0 A and the voltage at -3500 VDC.

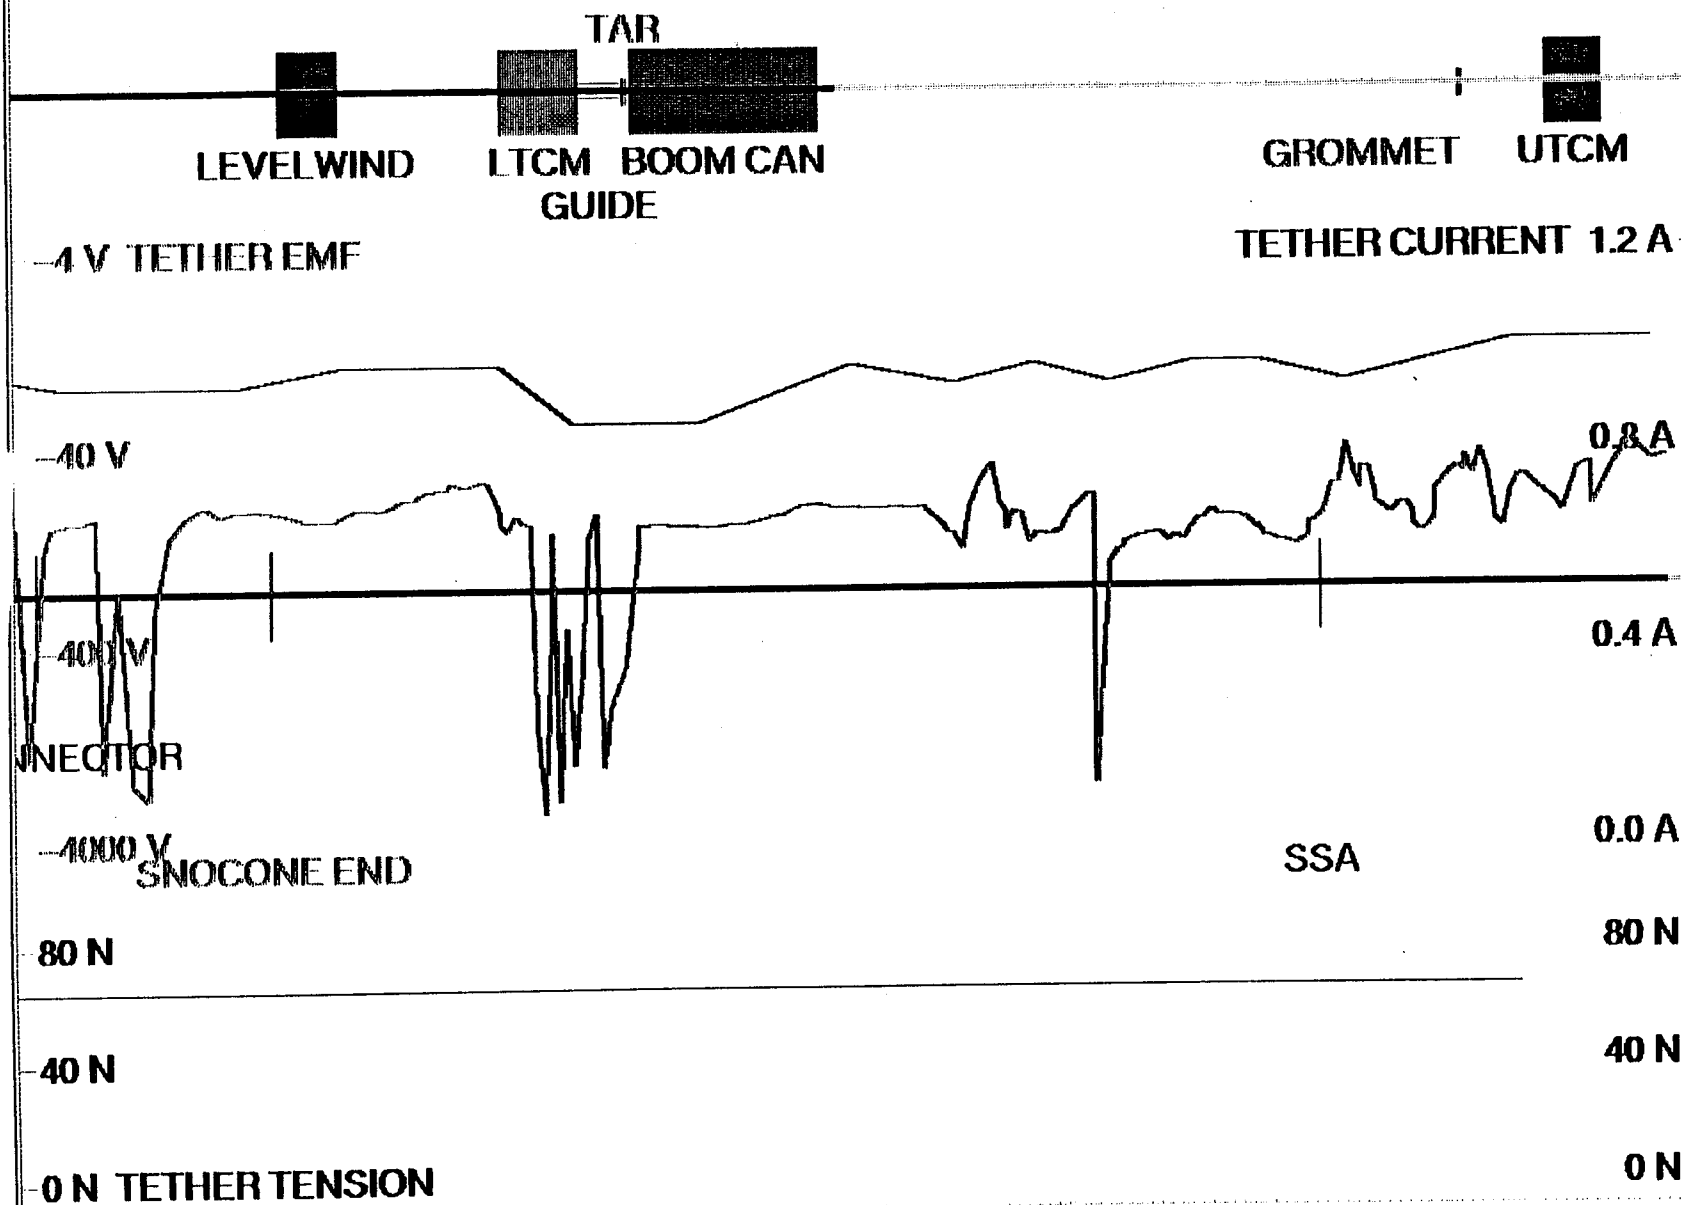
Figure 3.6-5

Figure 3.6-5: At 57/01:29:20.4, the damaged tether point exited the snocone, and the current remained steady at 1 A. The voltage remained at approximately -100 VDC, except for five or more spikes/recoveries until the damaged tether point exited the SSA and entered the boom.

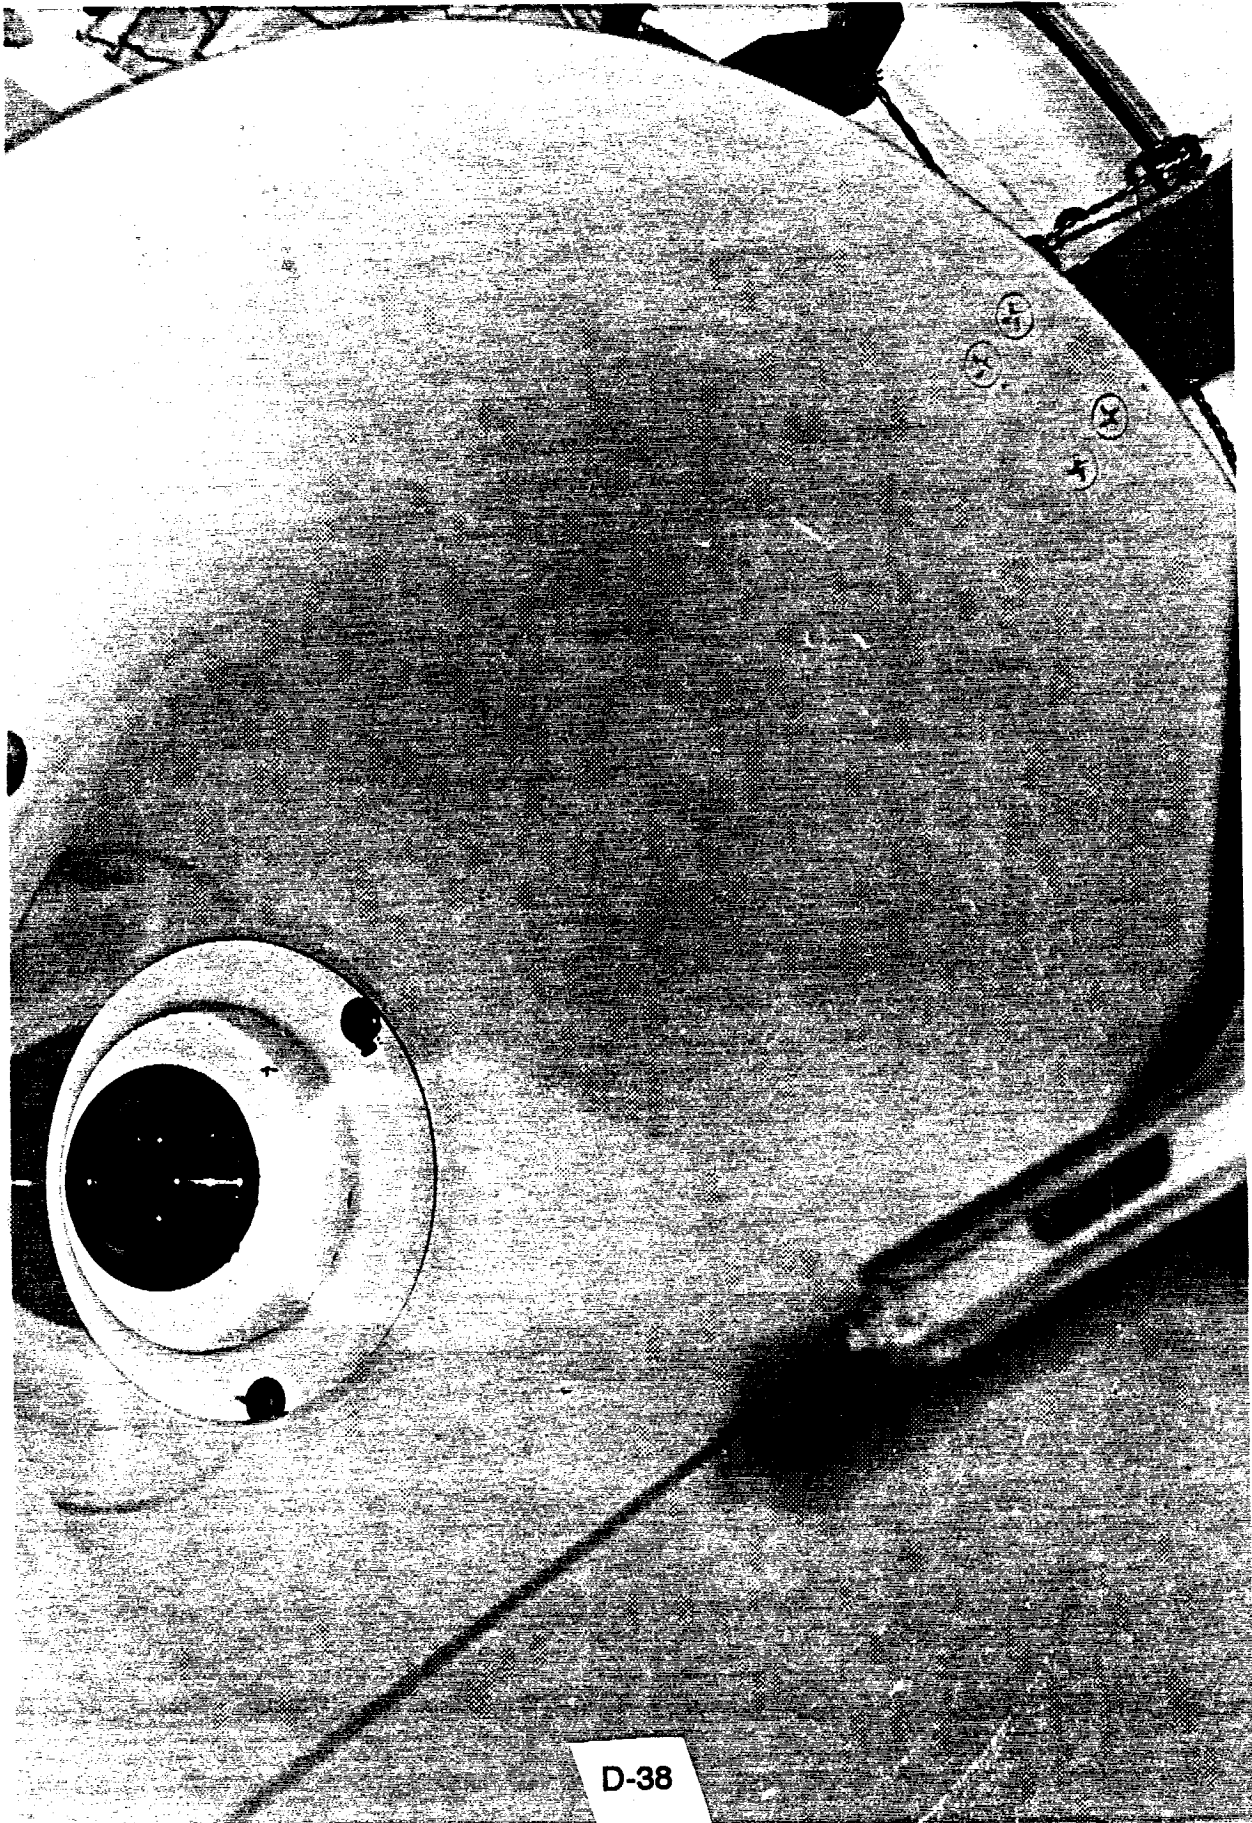
Initial inspections, prior to removal of any hardware, including the multiple layer insulation (MLI) blankets, were performed by the MSFC and KSC Inspection Team, including micrometeoroid inspection. One micrometeoroid impact on the upper outside rail area of the TSS structure was found (see photo attachment 5). This impact was outside of the MLI cover therefore was not a factor in the failure of the tether.

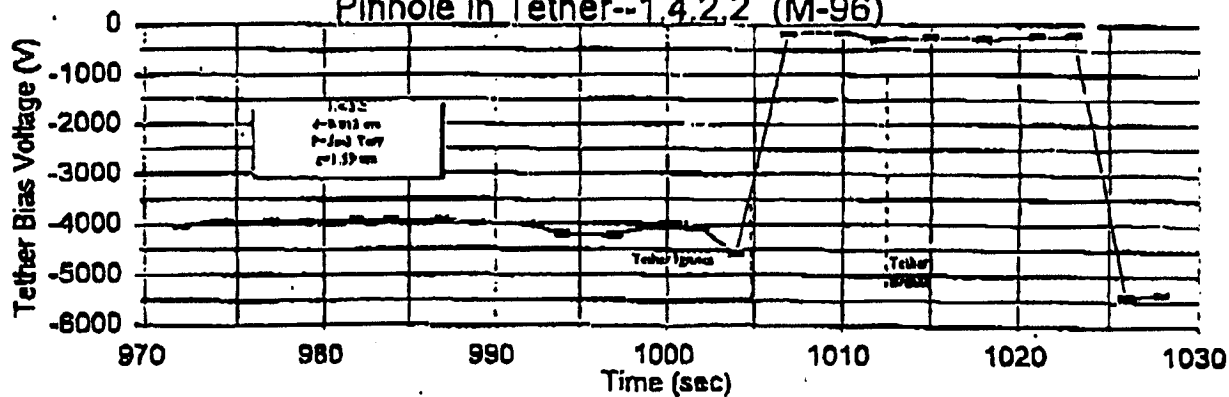
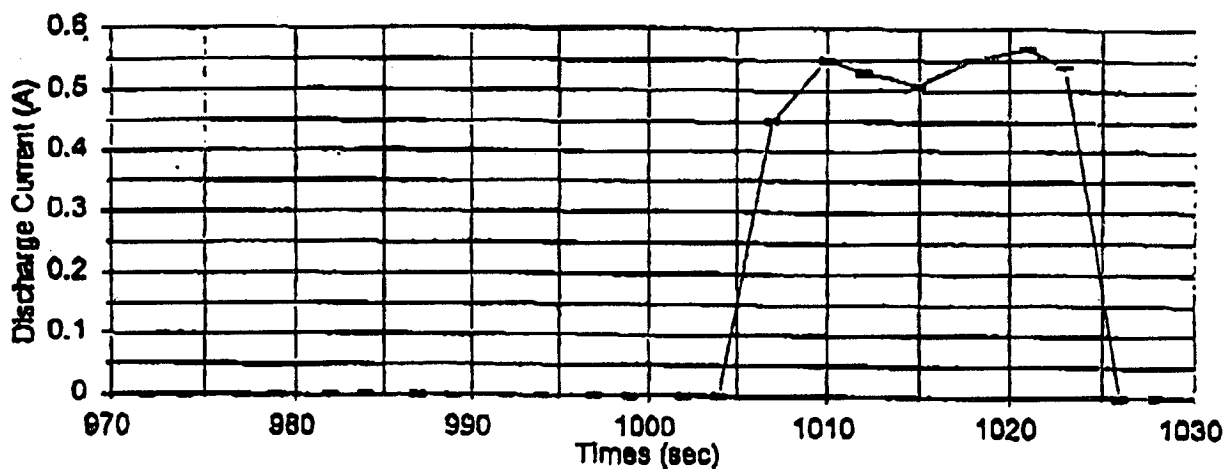
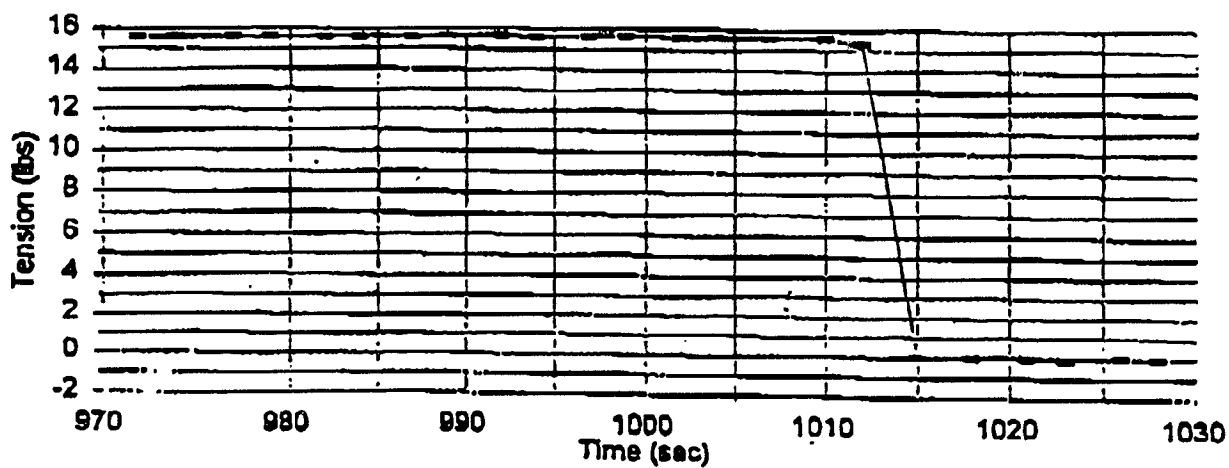
Pinhole in Tether--1.4.2.2 (M-96)

Examination of more than 3 m of the flight tether has revealed the presence of foreign matter located in each component of the tether: in the Nomex cover, in

the Kevlar tows, inside the FEP insulator tube walls, and inside the copper/Nomex core. These particles could have been co-extruded with the FEP, or they could have been on the surface of the copper/Nomex assembly during the extrusion process and become embedded in the FEP wall. The particles found inside the FEP tube wall lend some credence to the scenario of a particle possibly breaching the insulator and allowing arcing. However, no particles large enough to span the entire wall thickness (~ 0.012 inch) causing a hole all the way through the insulator have been found to date.

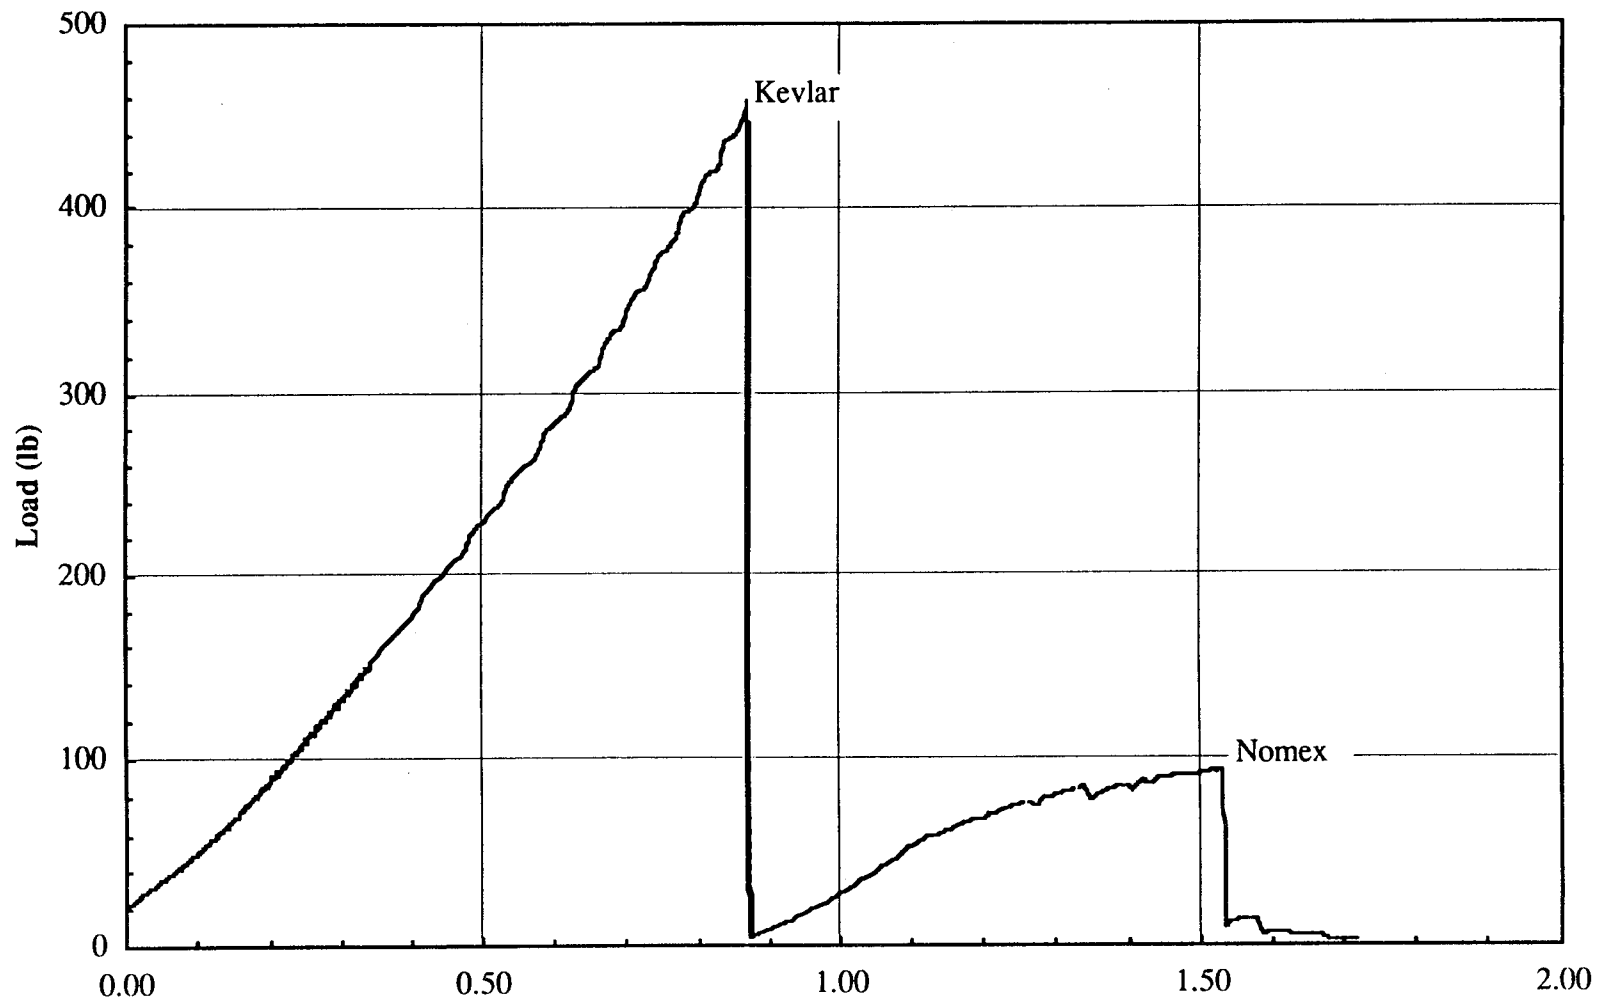
### Tether Tensile Characterization

- Objectives: Pull standard specimen lengths of tether in tension until breakage occurs, (1) to establish a baseline for all other mechanical testing, (2) for comparison to tether qualification data to assess aging effects, (3) to provide visual evidence of fracture modes and appearance, valuable for comparison to actual flight tether failure(s), and (4) to verify tether tensile strengths at design temperature extremes
- Results: Thirty specimens pulled at room temperature  
Statistically no different from tether qualification data

Temperature is not an issue (tether was operating at ~5 °C at time of failure) - recommend no additional testing at temperatures other than room temperature

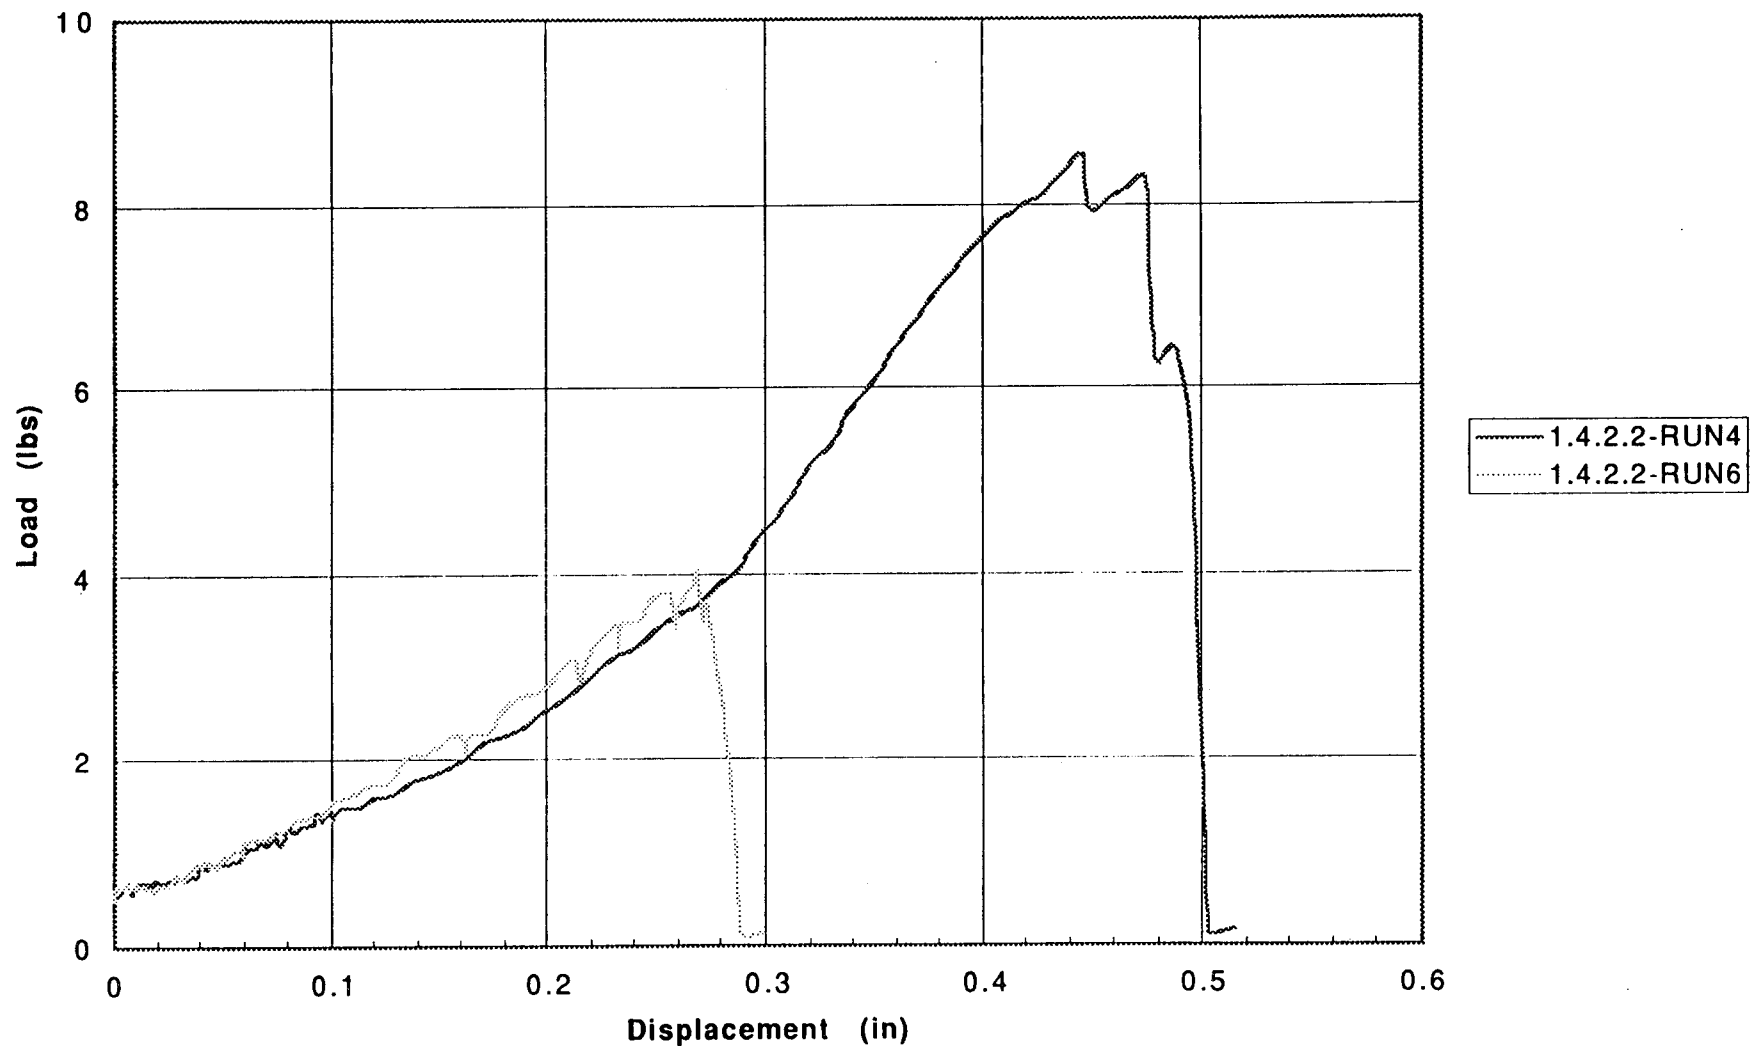
### Electrical Discharge Tether Specimens

- Objective: Simulate arcing on standard specimen lengths of tether, then pull in tension until breakage occurs - compare breaking load to known capability of tether
- Results: Two test specimens tested  
Significant charring on tether specimens  
Failures occurred at less than ten pounds force
- Observations: Recommend closure of this test series - electrical testing under simulated flight loads are better indicators of tether performance

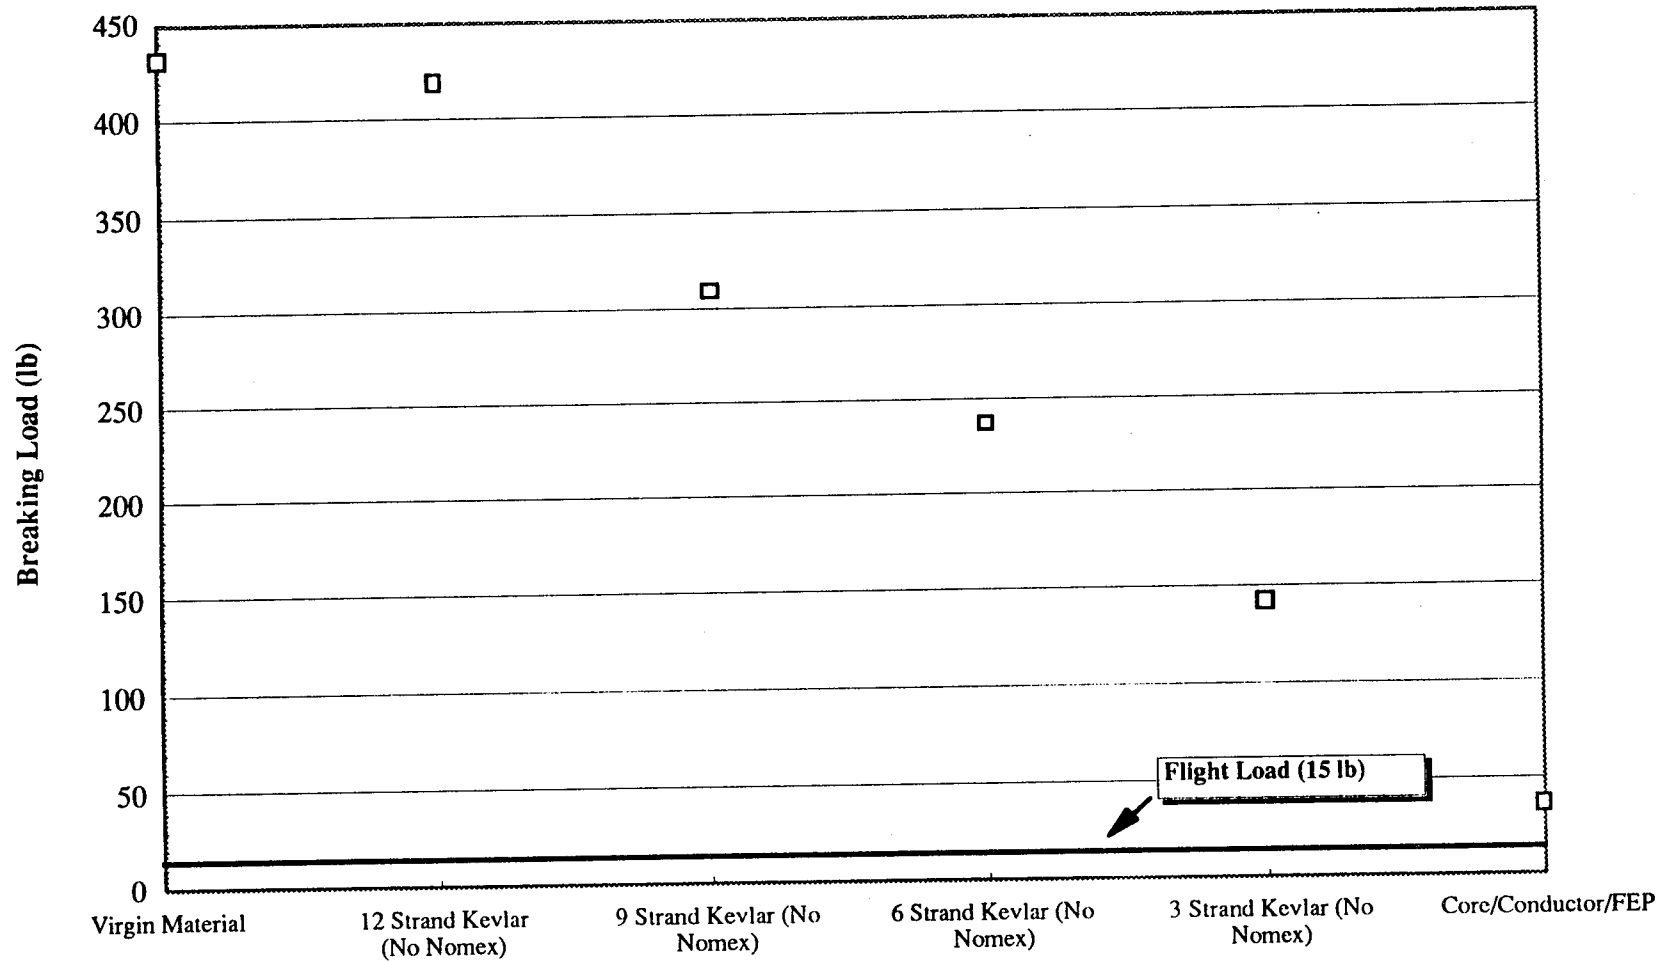
Effect of Material Removal on Tether Strength  
@ Room Temperature

- **Objective:** Remove known quantities of material from tether specimens, then pull in tension until breakage occurs - compare breaking load to known capability of tether
- **Results:** Three test specimens per condition tested  
Successive material removal led to lower strength  
All failures occurred well above known flight loads
- **Observations:** Recommend closure of this test series

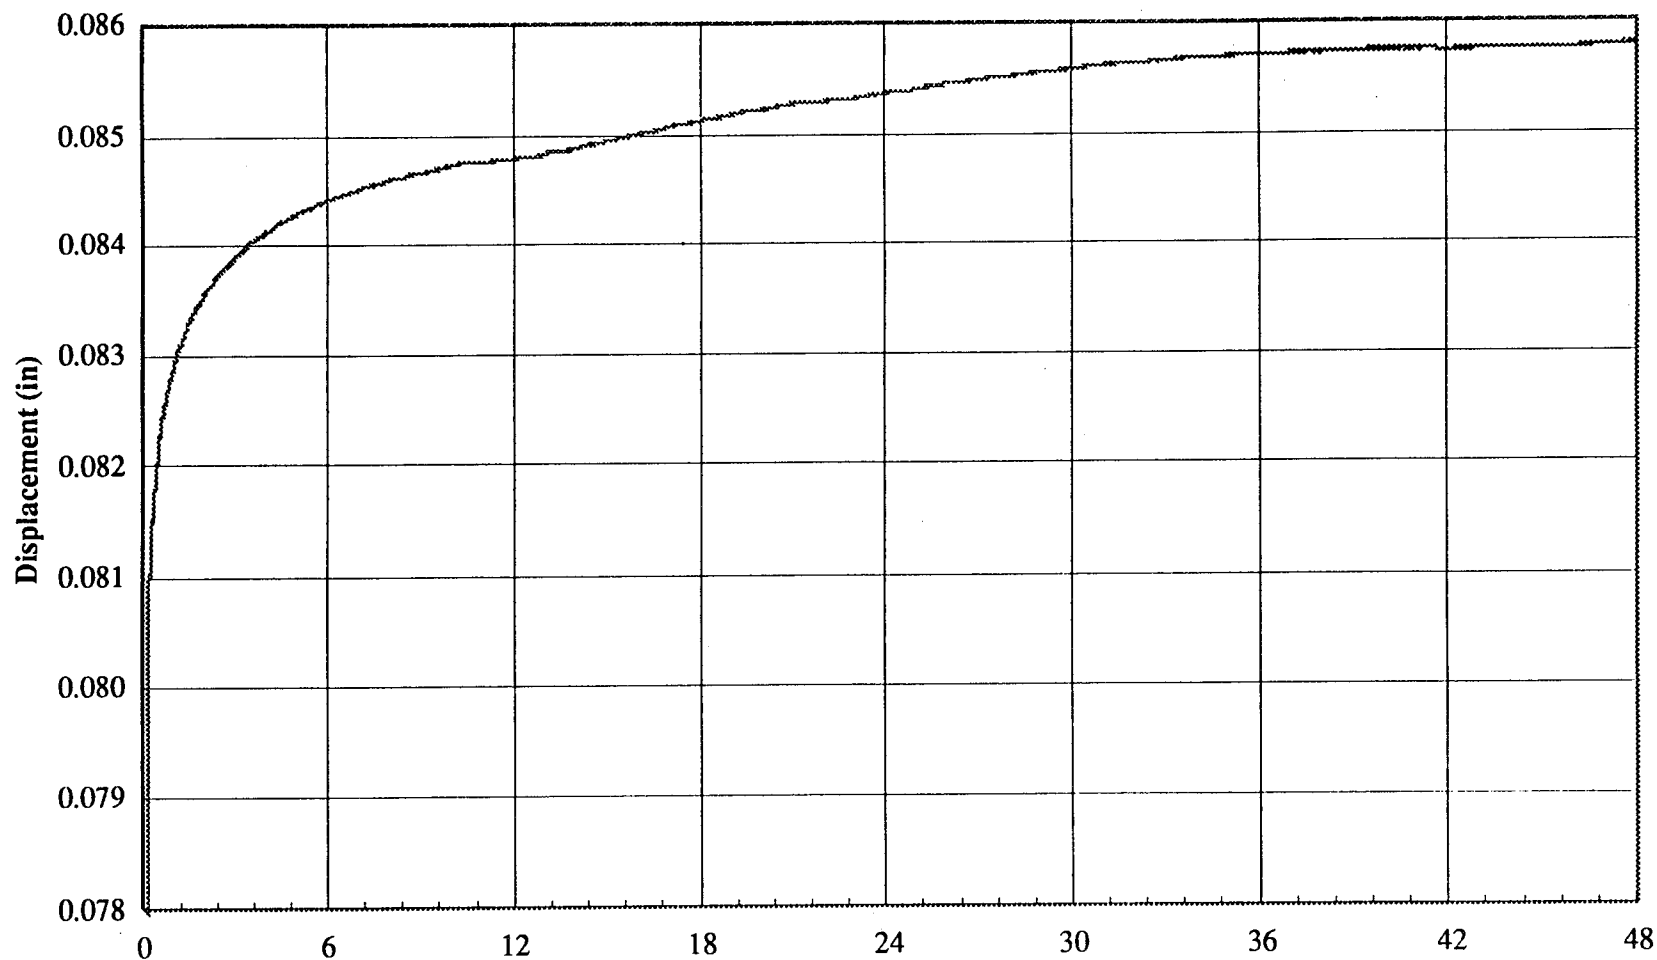
Compressive Creep Test (254 lbs)

Remaining specimens to be subjected to electrical breakdown, X-ray, and cross-sectional examination
- Observations: Creep alone does not appear to be an issue  
Additional tests pending Board actions/recommendations
